HAZARDOUS MATERIALS SURVEY

Pre-Renovation

Asbestos and Lead-Based Paint

*Community Center
784 Charlton Road
Charlton, NY*

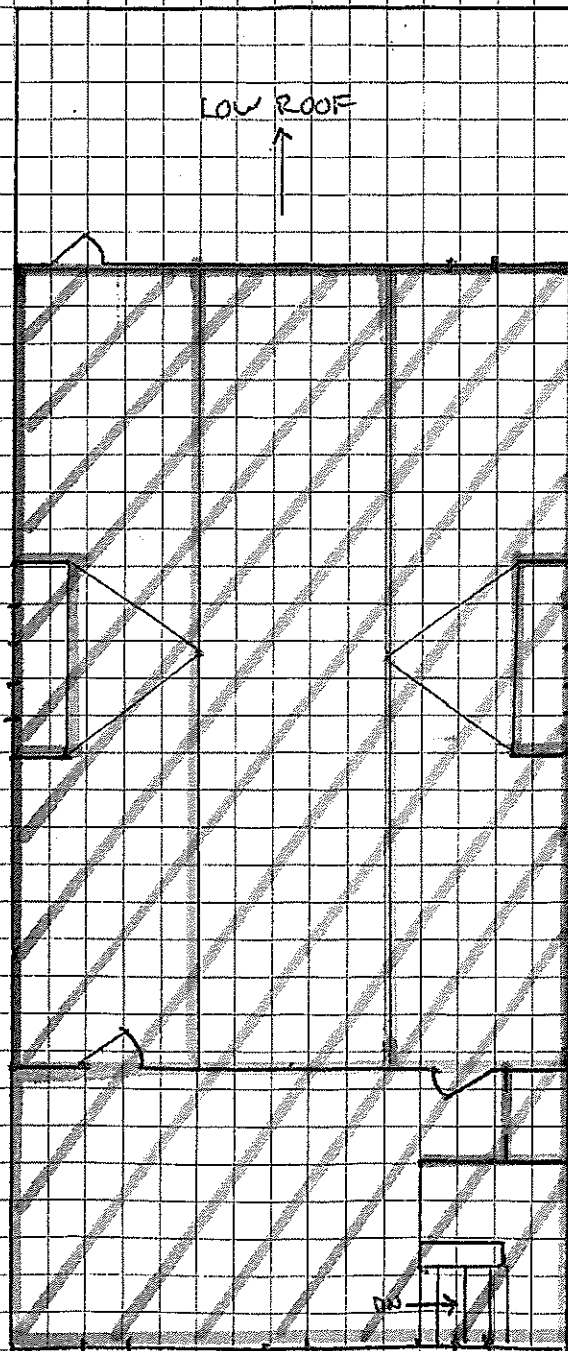
PHASE Asbestos Material Locations

Drywall Joint Compound
03-01

Plaster Wall
(Residual)
12-01

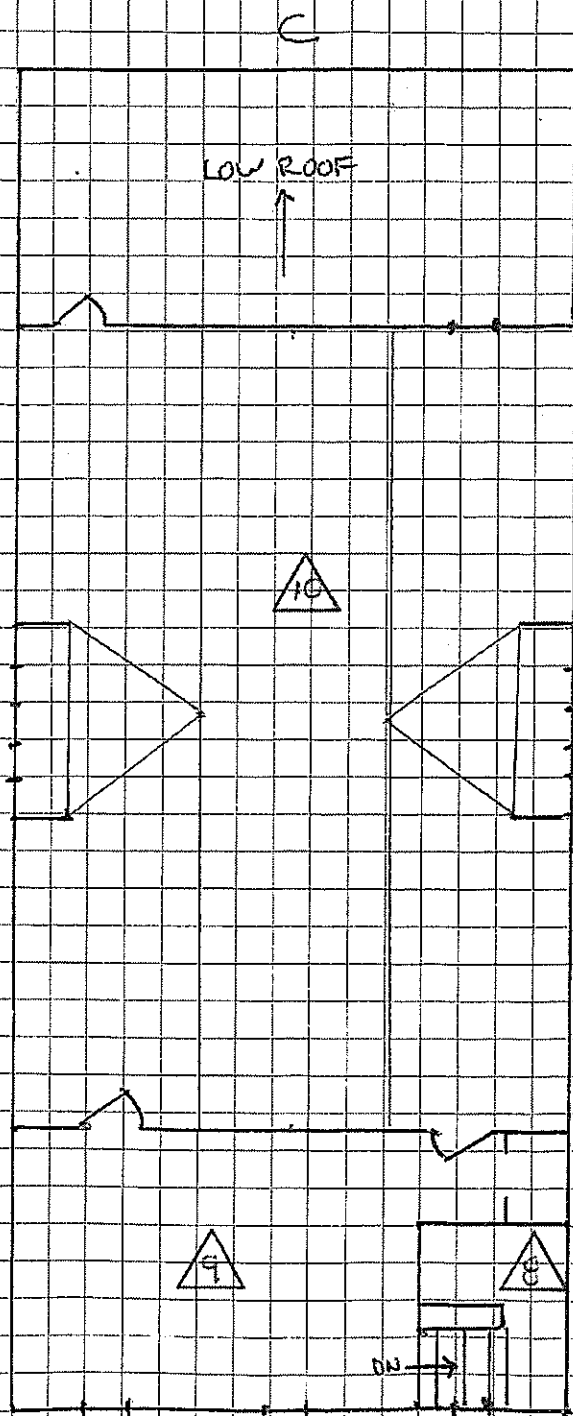
PHASE Lead Based Paint Room Locations

Lead Based
Paint Room
Number

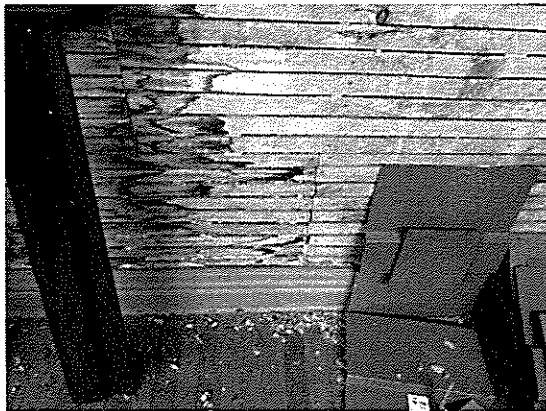
There is an asbestos incidental disturbance on the 2nd floor of plaster. This disturbance will require a contamination assessment and the potential development and submission of a NYS DOL Site Specific Variance to allow for the clean-up and abatement of this material by a NYS licensed and certified asbestos abatement contractor. This area should be cordoned off and not occupied by any uncertified asbestos personnel until the proper cleanup has been completed.

Photograph 2 – 12-01 Plaster Wall (Residual) Second Floor
