Charlton Community Center

Conditions Assessment Report

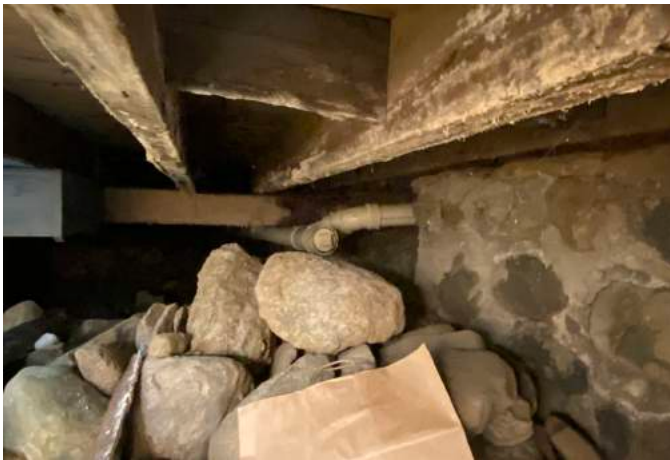
Figure 4 West foundation wall and decaying floor framing.

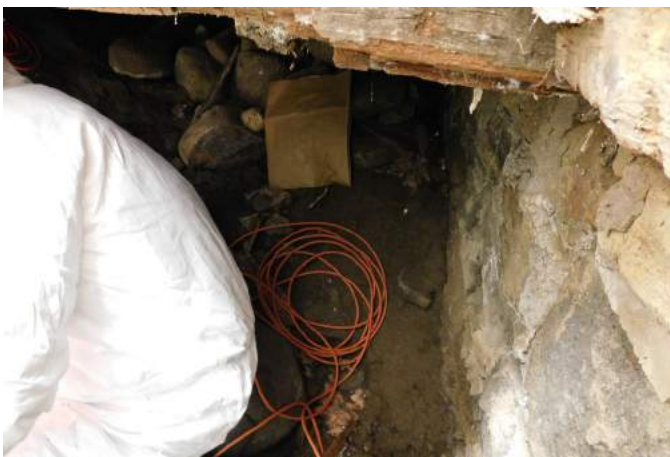
Figure 5 North foundation wall and rotted floor framing.

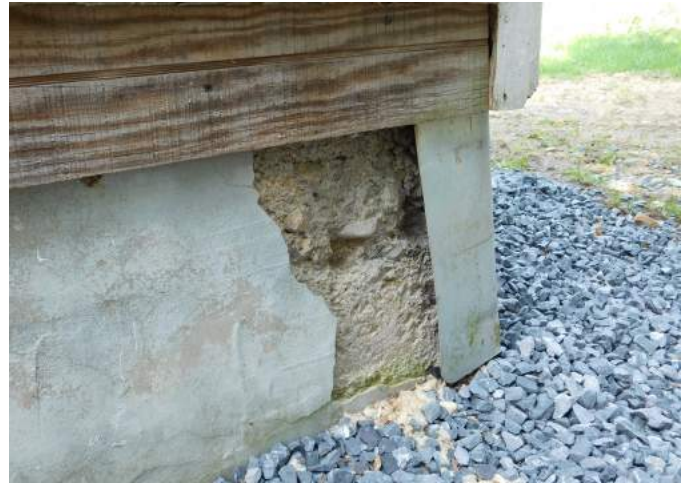
Figure 6 Spalling on rear addition concrete foundation.

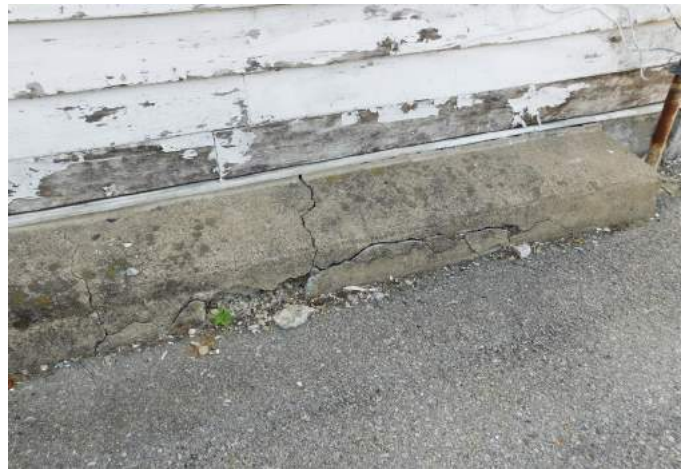
Figure 7 Cracked concrete wash along west foundation wall.

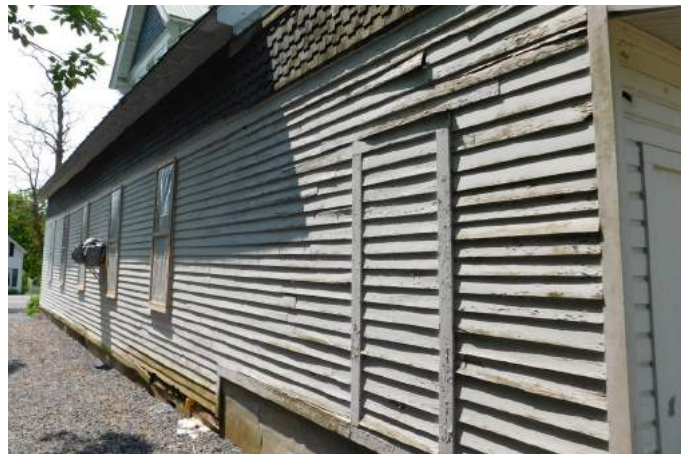
Figure 8 Deteriorating weatherboard on east elevation. Note also deteriorated former door casing.

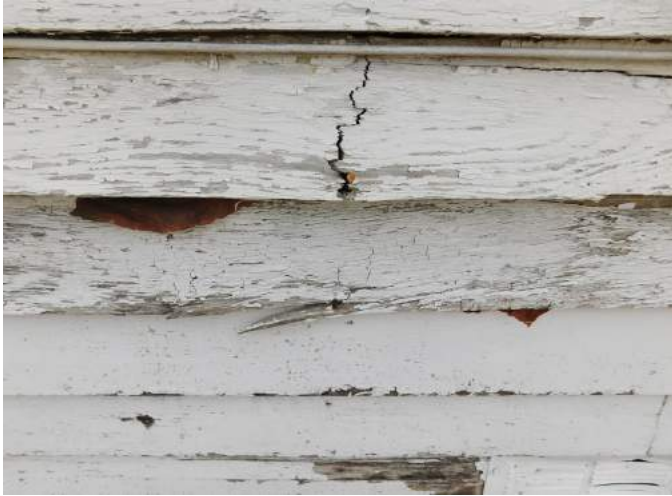
Figure 9 Typical paint loss and less common cracking and rot on weatherboards.

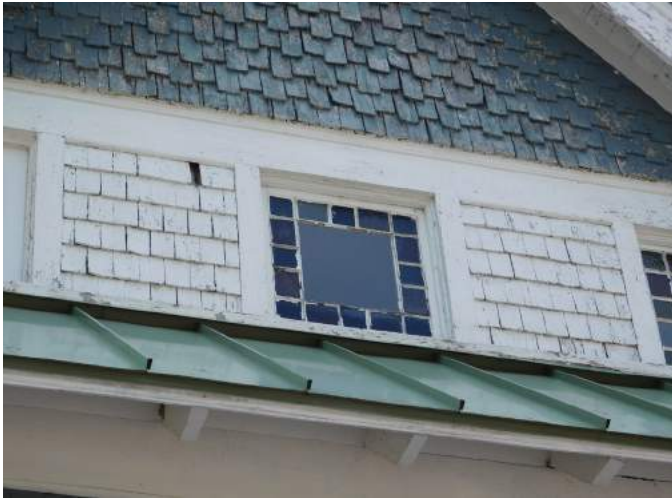
Figure 10 West gable showing typical wood shingle condition. The inner faces of two parapet walls extending above the roof line of the shed roof of the rear addition are faced with fiber board siding panels. They are severely deteriorated at the roof line and exhibit paint loss.

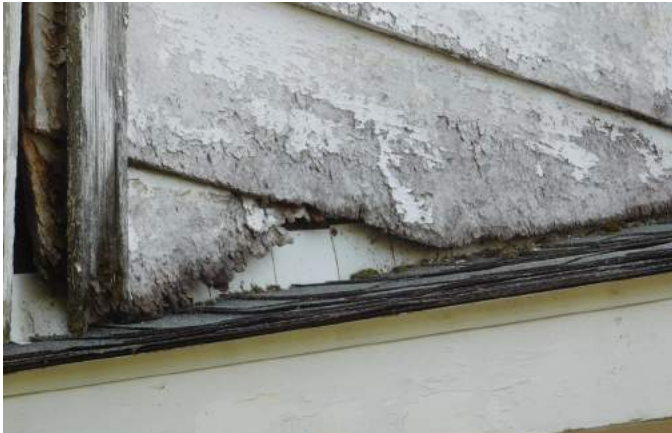
Figure 11 Deteriorated rear addition parapet wall cladding.

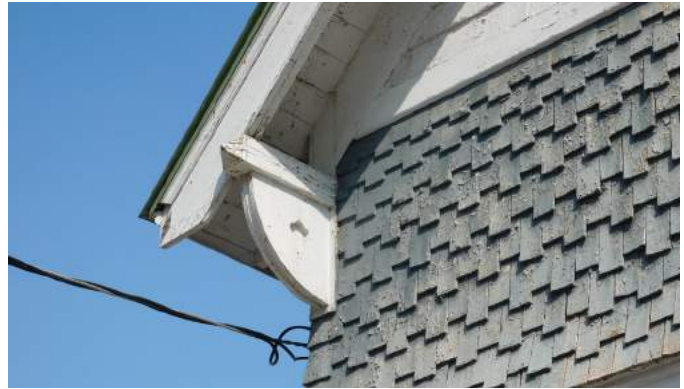
Figure 12 Typical bracket, fascia board, frieze board, and eaves showing paint loss.

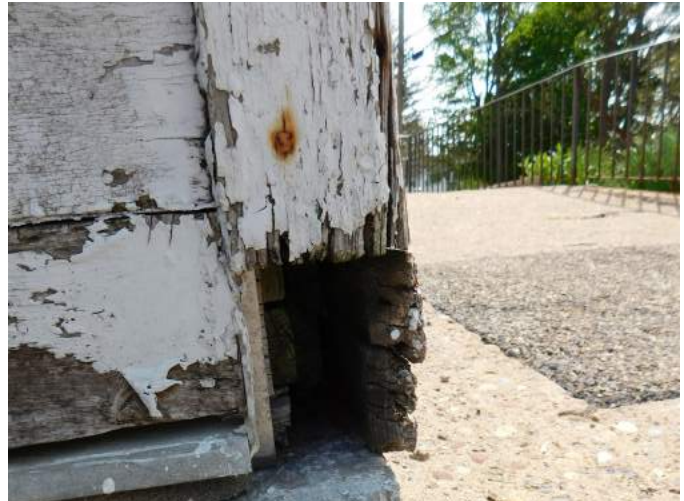
Figure 13 Deteriorated southwest corner boards.

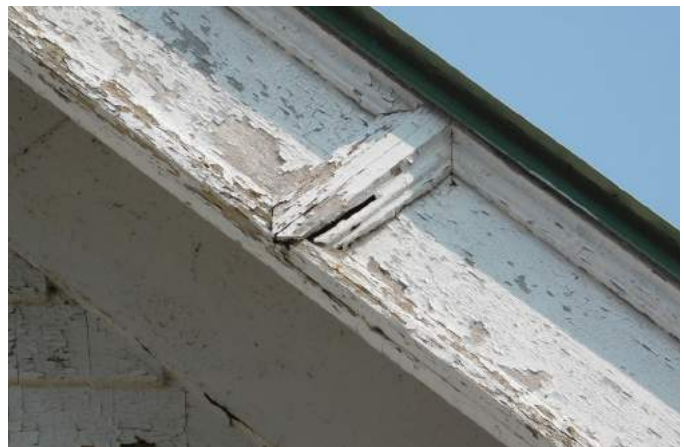
Figure 14 Rotted fascia trim element.

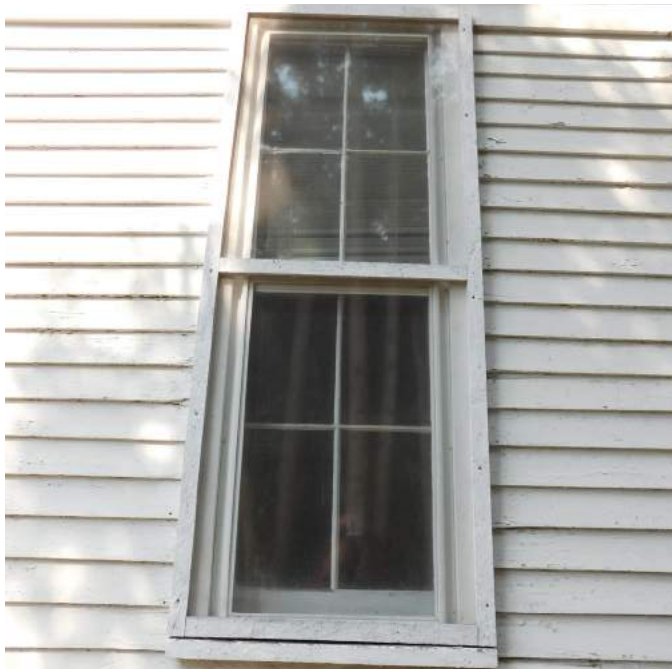
Figure 16 Typical four-over-four first-floor window. Note missing muntin in top sash.

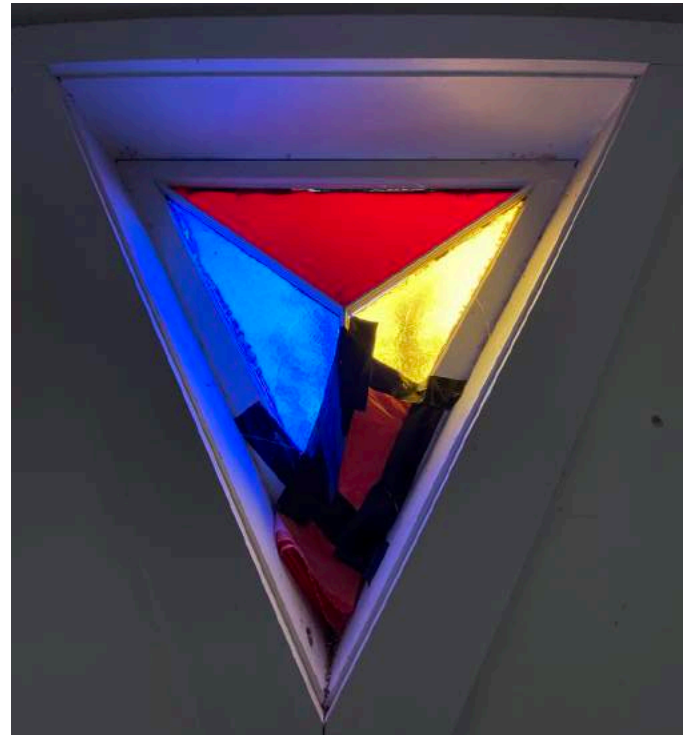
Figure 17 Interior of colored-glass window showing slipped upper pane.

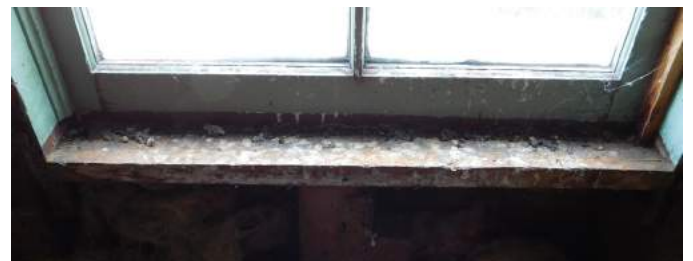
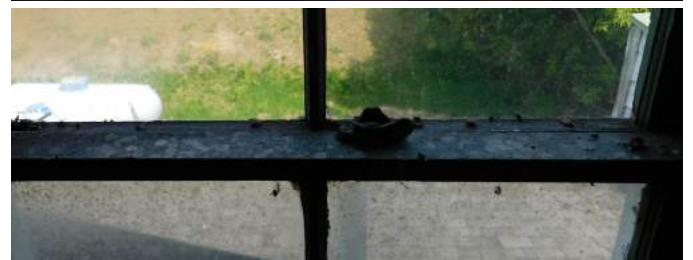
Figures 18-19 Details of north elevation second-story window. Note surface cracking at stile and rail joints, sill, and meeting rail.

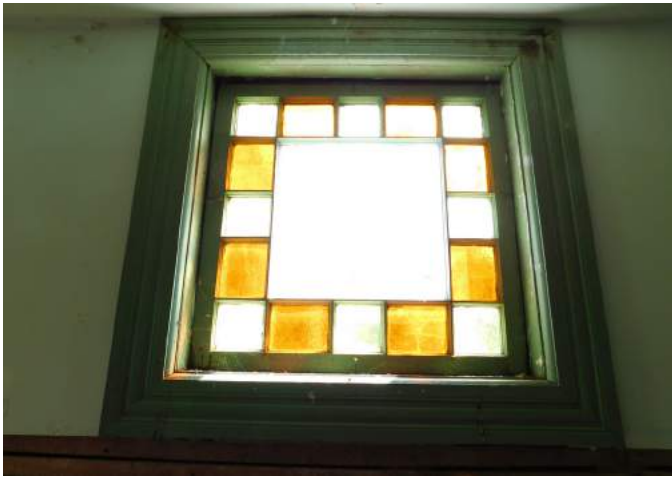
Figure 20 Typical square dormer window. This one exhibits two cracked panes and deterioration at the bottom left of the frame.

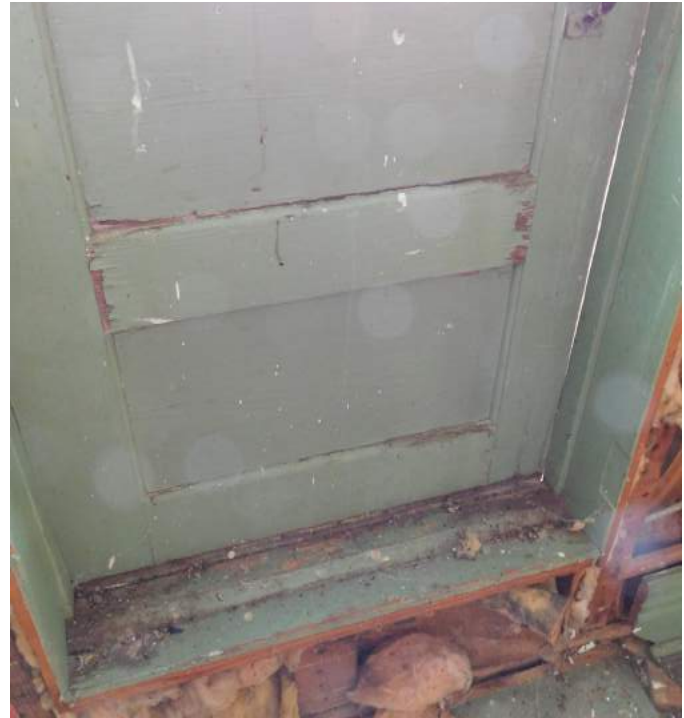
Figure 21 Bottom half of door leading to rear addition roof. Paint loss and rot at stile and rail meeting joints is due to water ingress from joint separation.

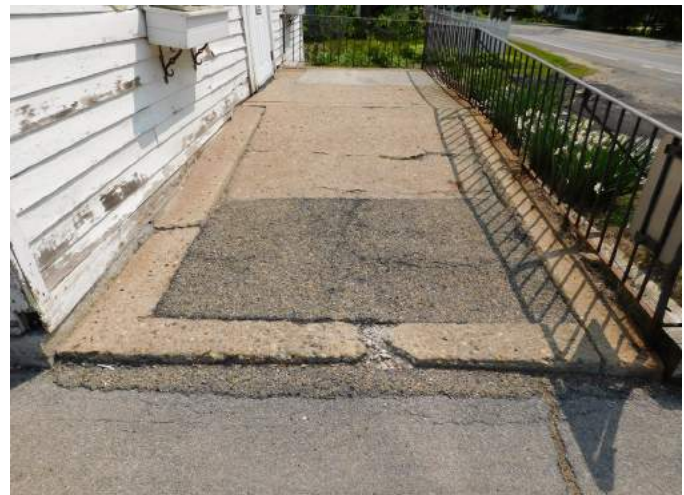
Figure 22 Cracked and disintegrating concrete ramp with asphalt patch. Erosion of binder and loss of aggregate as well as contact with corroded metals has weakened the structure and caused cracking and deterioration.

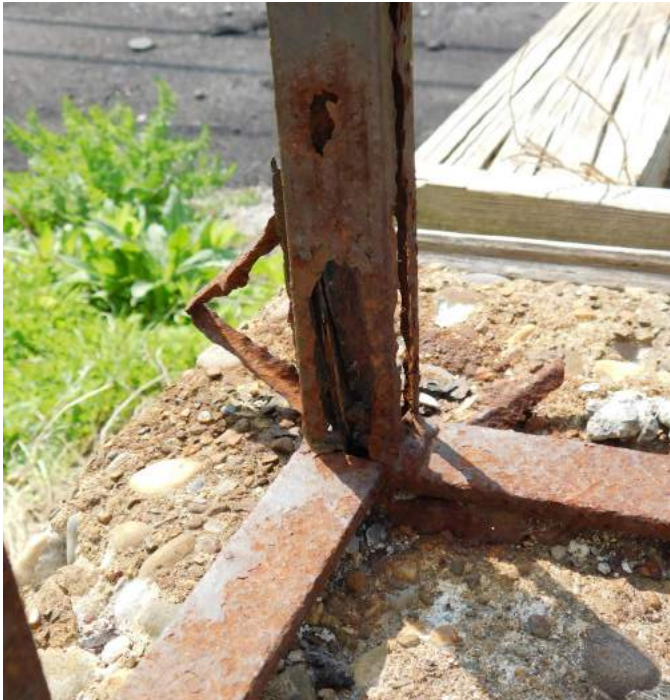
Figure 23 This heavily corroded iron railing post has damaged the concrete at its connection.

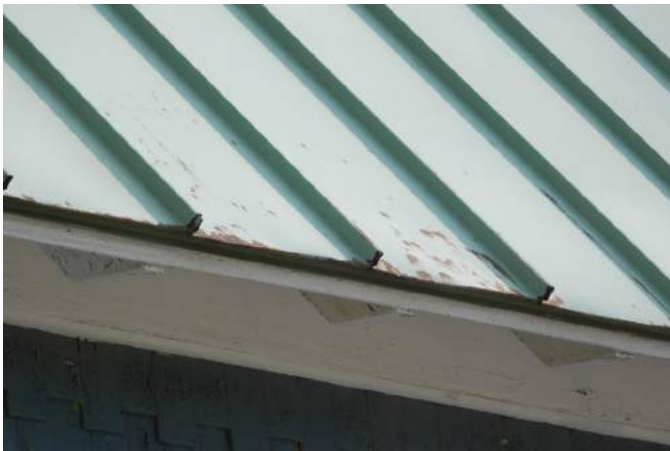
Figure 24 Typical minor corrosion at edge of metal roof.

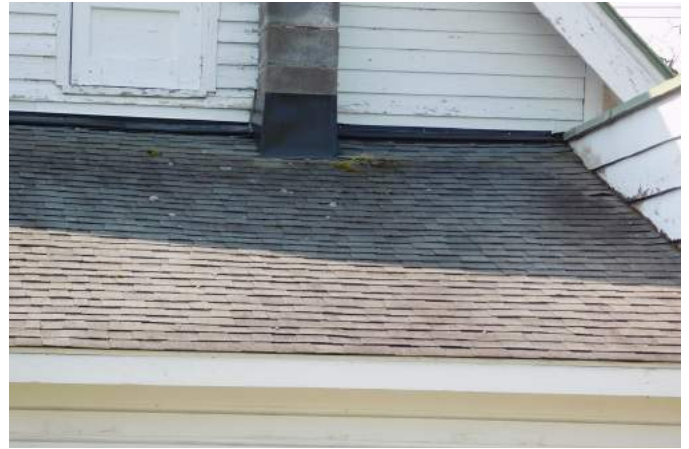
Figure 25 Asphalt shingle roof on addition.

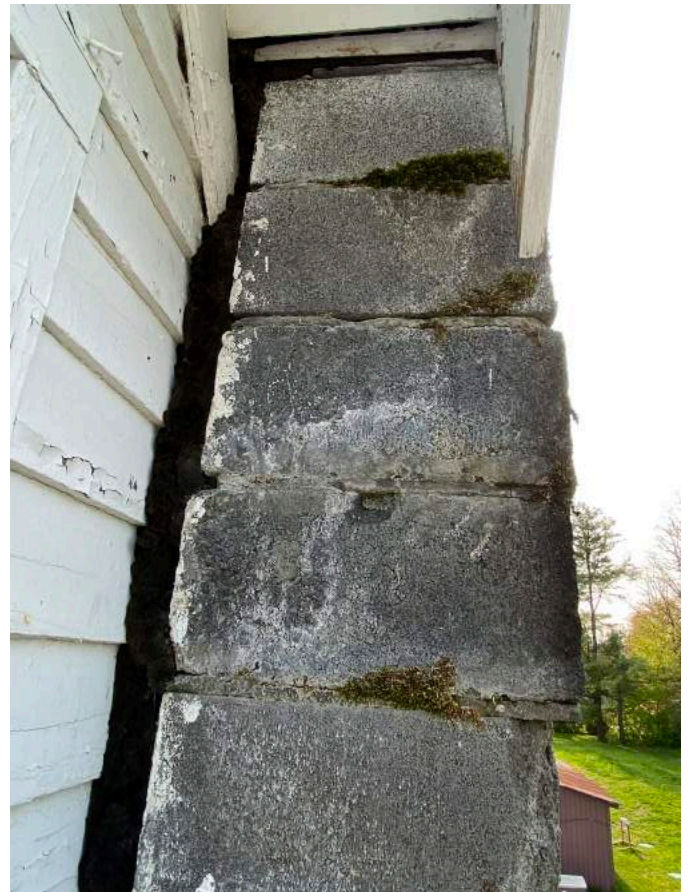
Figure 26 Detail of lower portion of chimney exhibiting a variety of material failures.

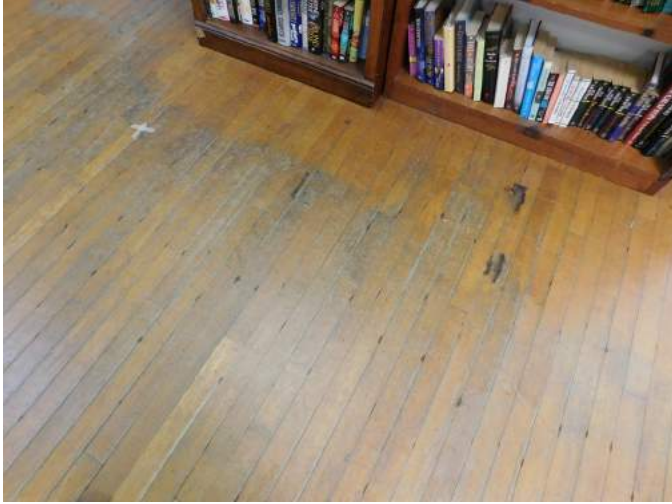
Figure 27 Detail of typical maple flooring condition.

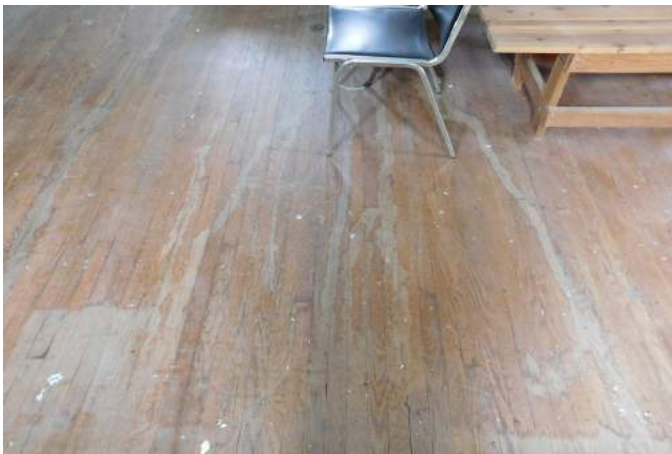
Figure 28 Detail of typical oak flooring condition.

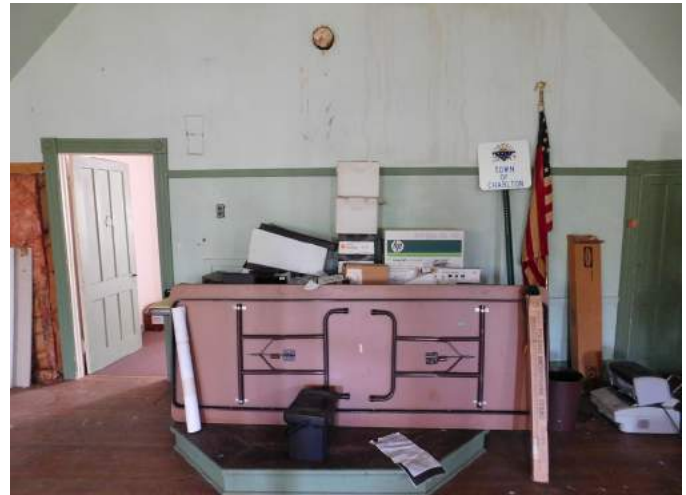
Figure 29 South wall of second floor hall. Note the chair and head rails and the water staining on the upper portion.

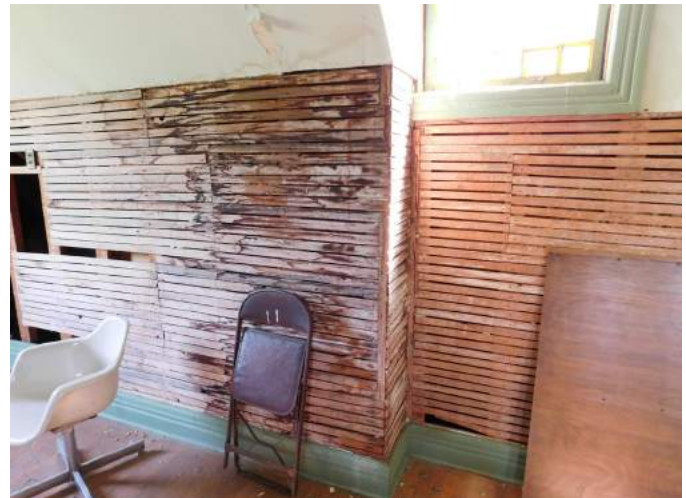
Figure 30 East wall of second floor hall. Note the water-stained lath and the historic baseboard.

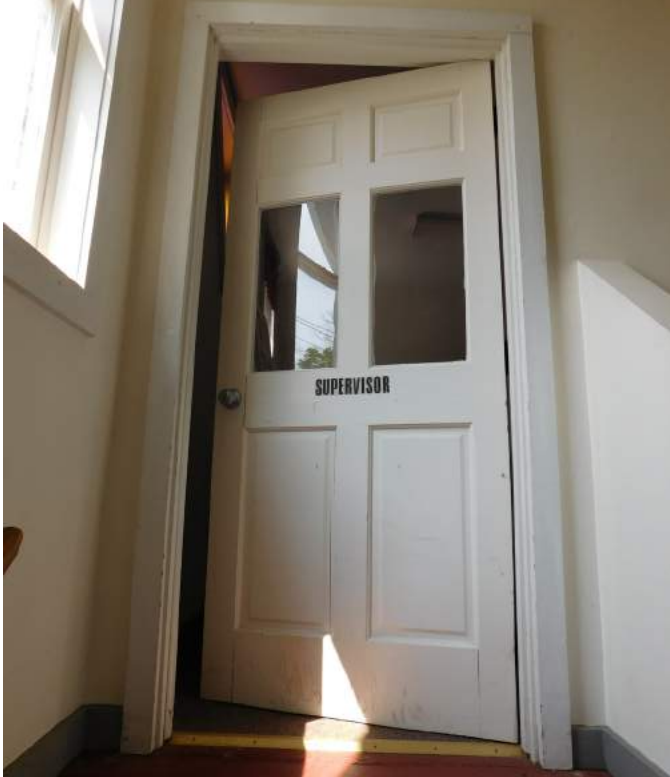
Figure 31 Second floor door with joint separation and marks.

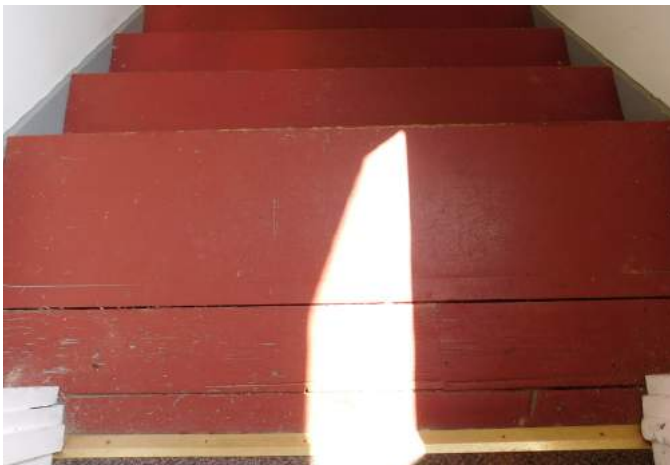
Figure 32 Top of staircase looking down. Note the scratches and gouges and slightly worn down tread nose.

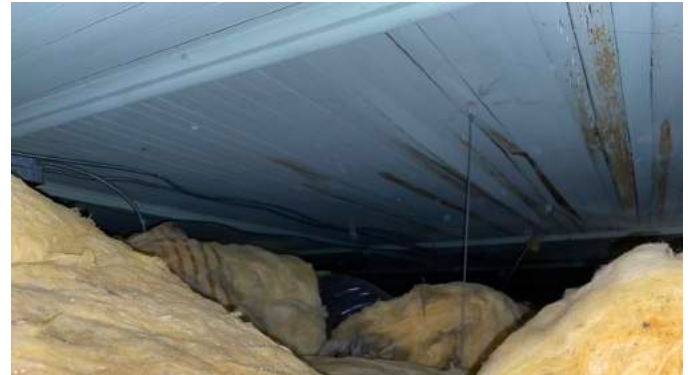
Figure 33 Concealed historic wood board ceiling above drop ceiling in main hall of first floor. Note the perpendicular trim pieces forming panels and the paint loss and warping of the boards.

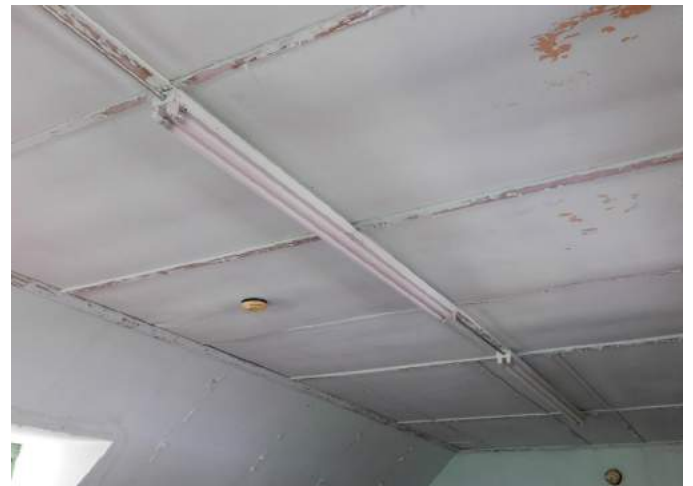
Figure 34 Warped gypsum board ceiling in second floor hall. Note paint peeling, particularly on battens.

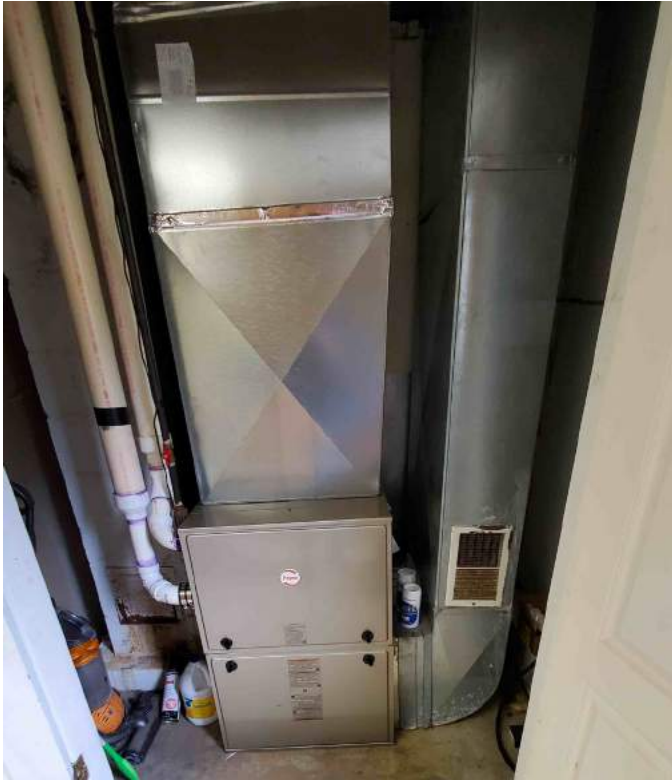
The building has one furnace, a Payne Model PG92ESAA60120DAA, SN 4222A57795. The unit is high efficiency, 120,000 BTUH input utilizing propane. The propane tanks are located outside the north end of the building. The unit serves the entire first floor and the front room of the upper floor. Supply and return ductwork is located above the first-floor ceiling. Diffusers and return grilles are located in the first-floor ceiling and in the floor of the second-floor front room. The unit is in excellent condition and was installed in the fall of 2022. The unit does not have a cooling coil. The system is controlled by a single thermostat located in the first-floor main room.

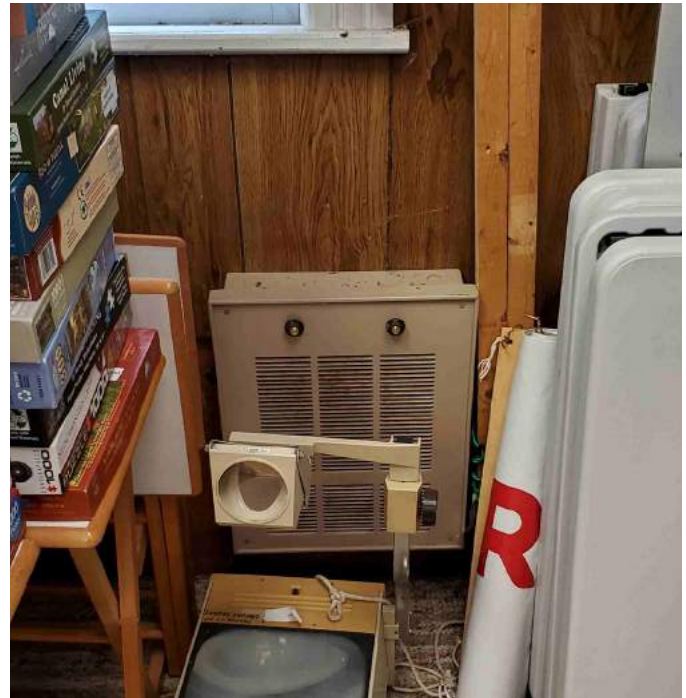
Figure 38 Storage Room Heater

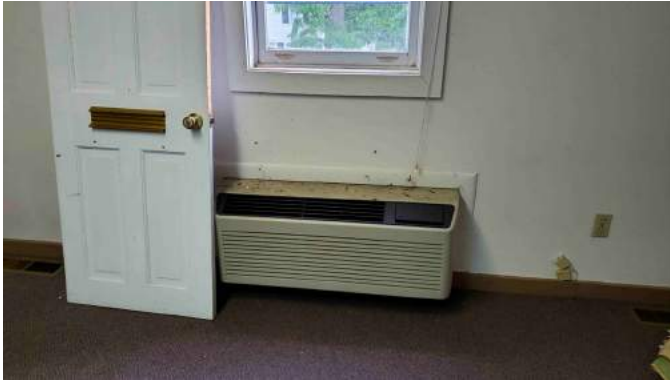
Figure 39 PTAC in Second-Floor Front Room

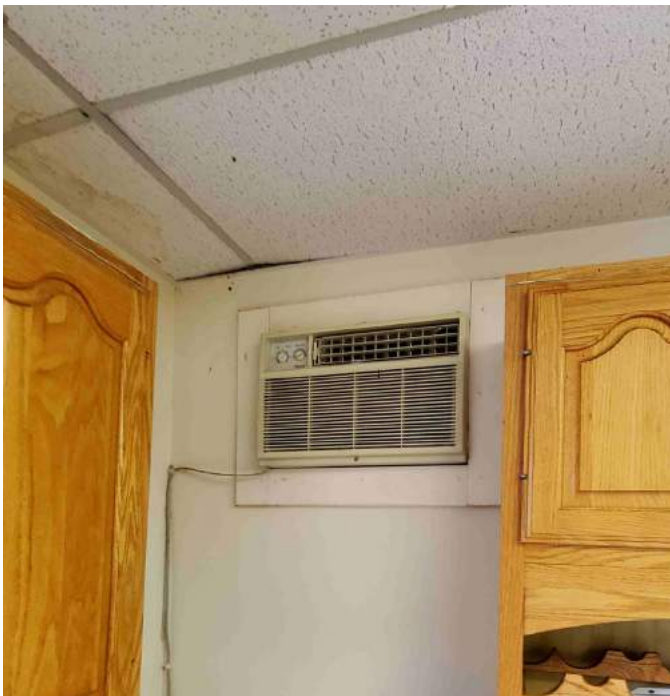
Figure 40 AC Unit in Kitchen

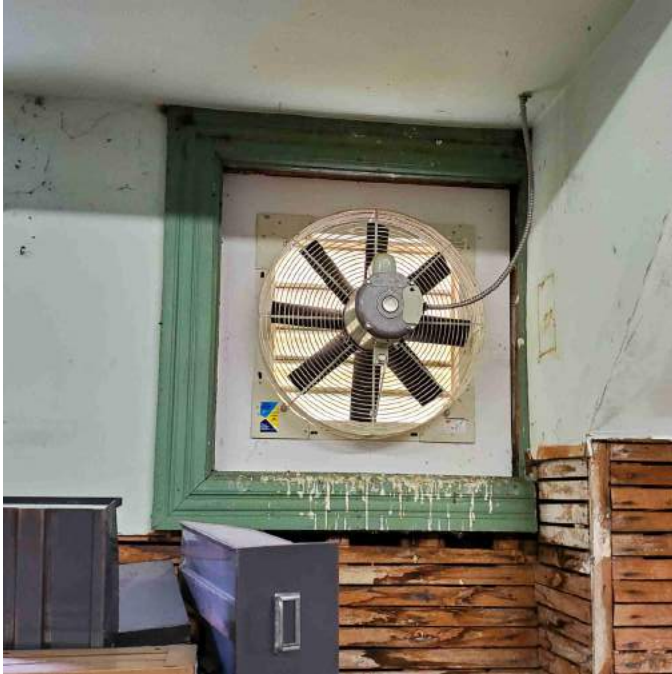
Figure 43 Second Floor Exhaust Fan

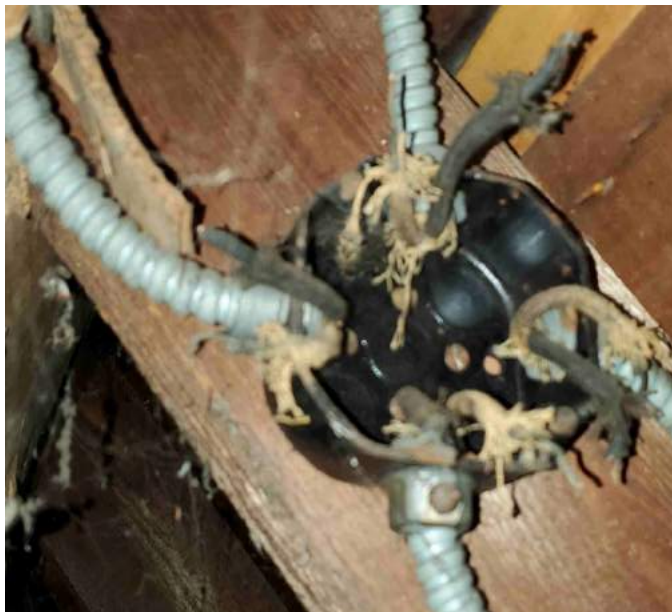
Figure 47 Abandoned Wiring

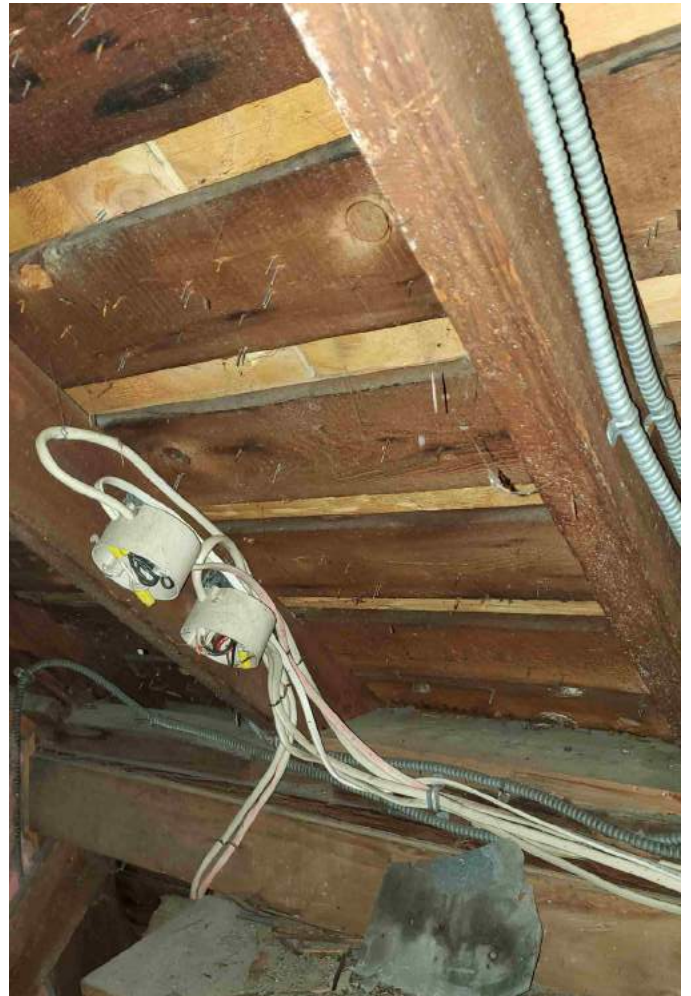
Figure 48 NM Cable Up From Main Panel

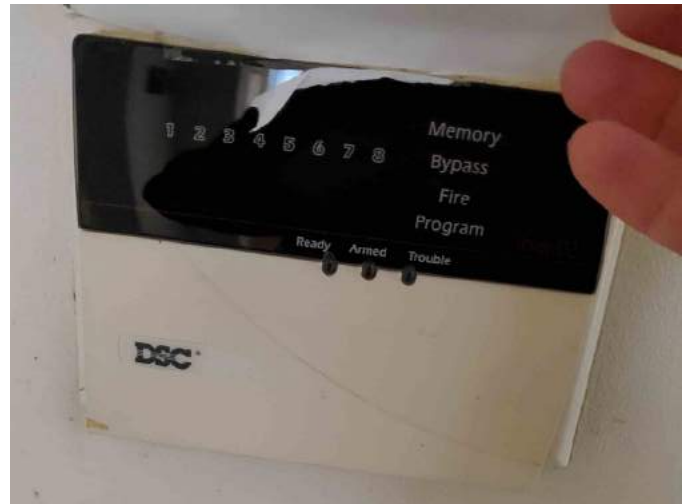
Figure 53 Security System Interface Panel

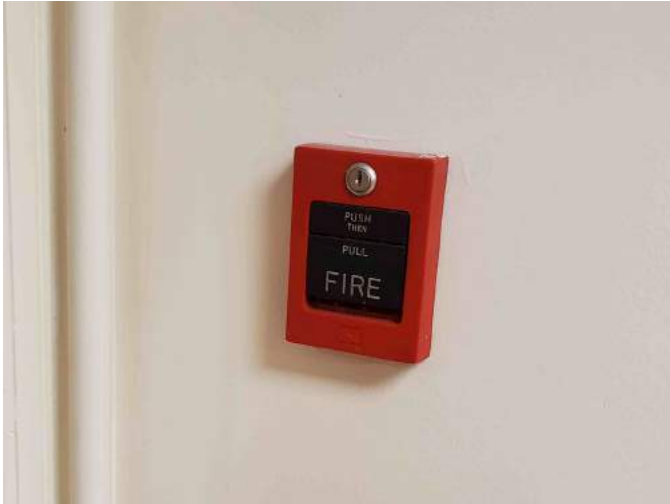
Figure 54 Typical Pull Station

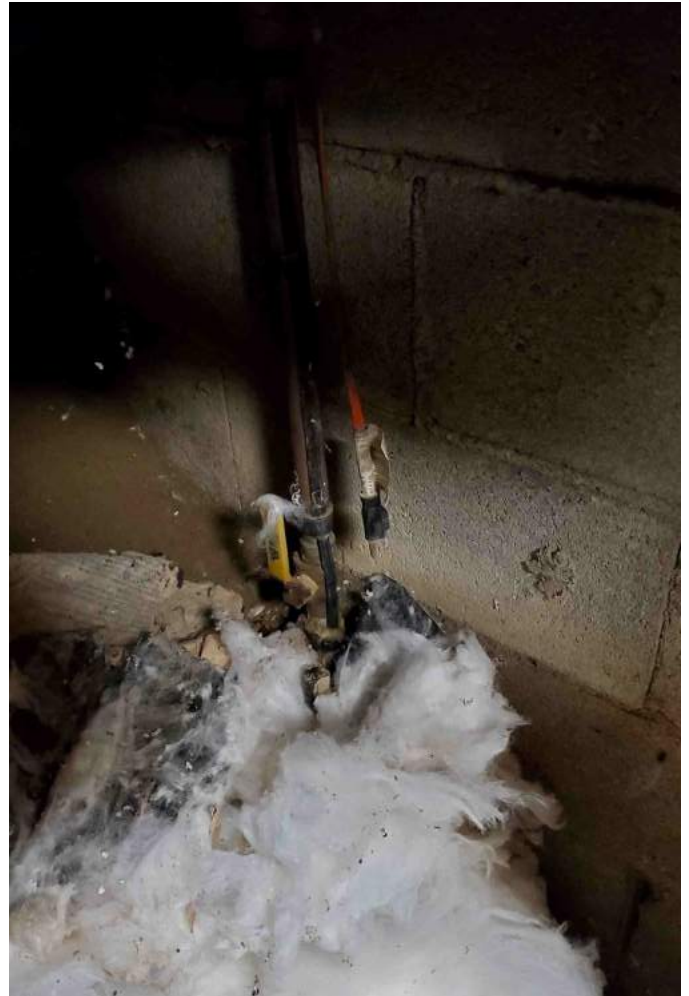
Figure 56 Water Service

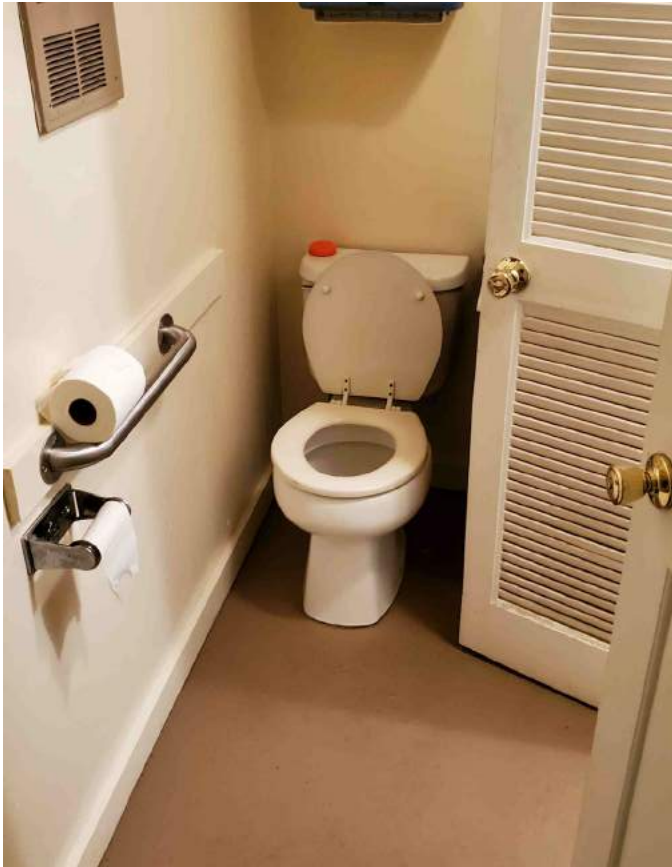
Figure 57 Restroom Water Closet

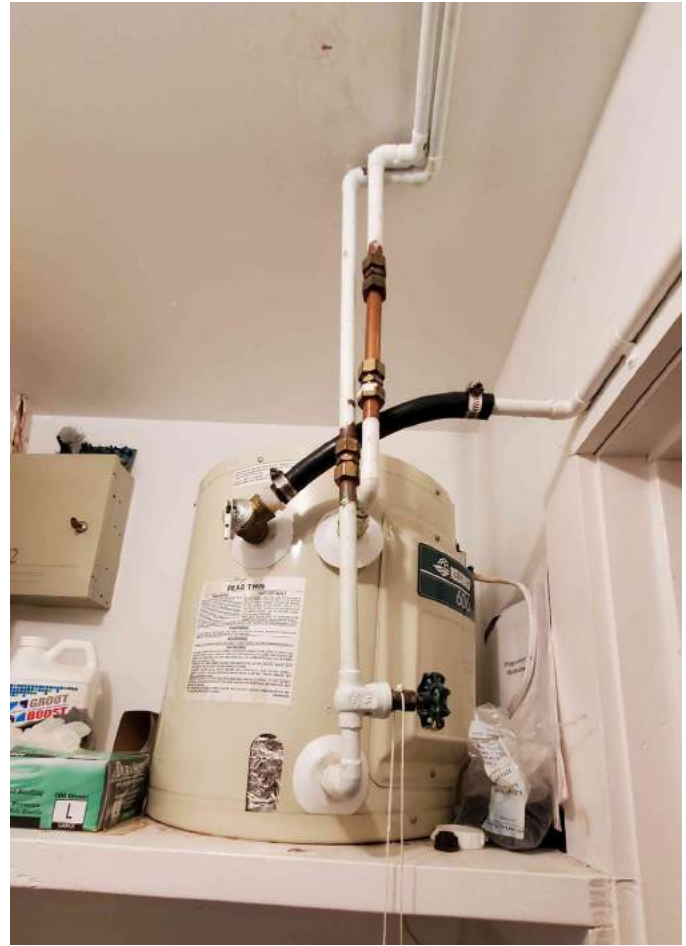
Figure 59 Water Heater

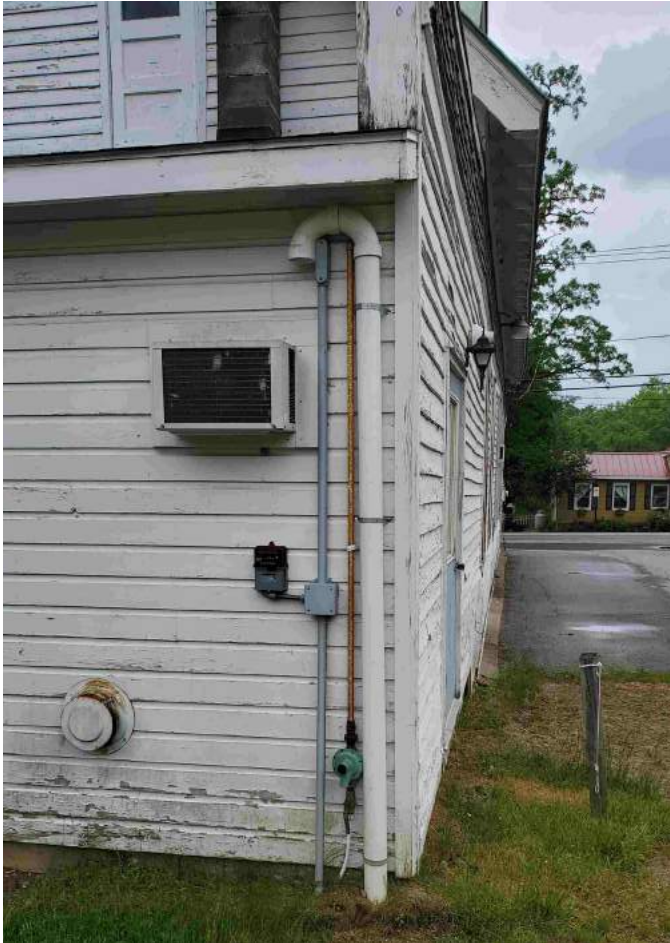
Figure 60 Raised Bed Vent

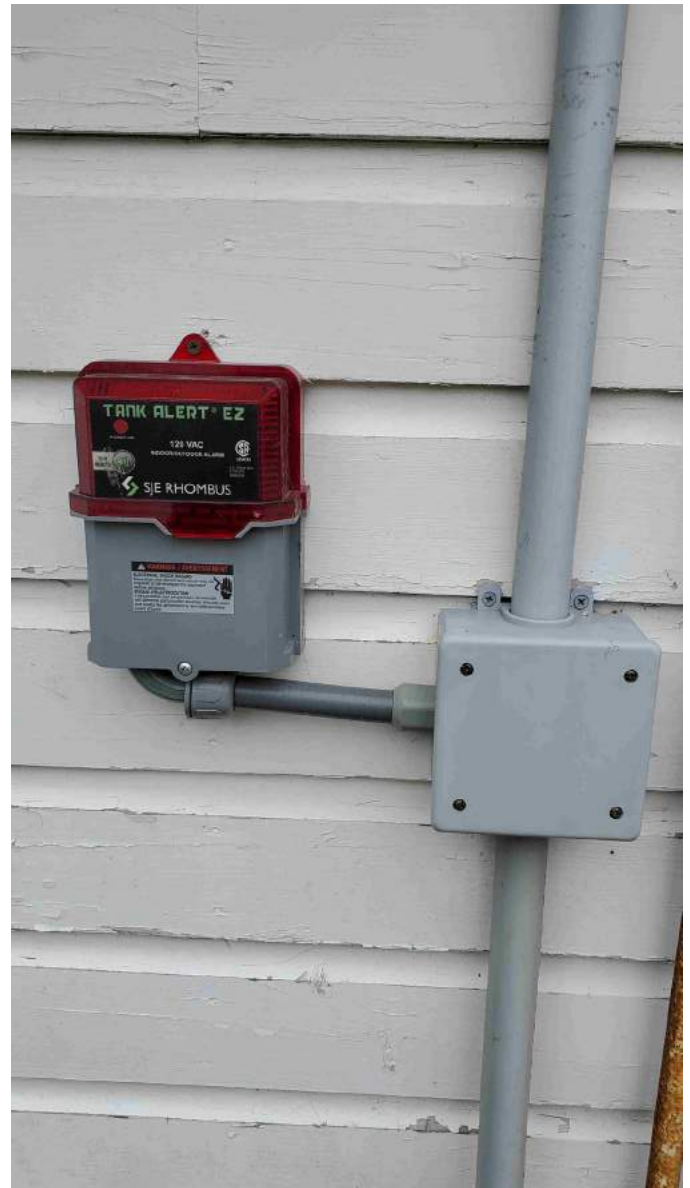
Figure 61 Raised Bed Pump Power

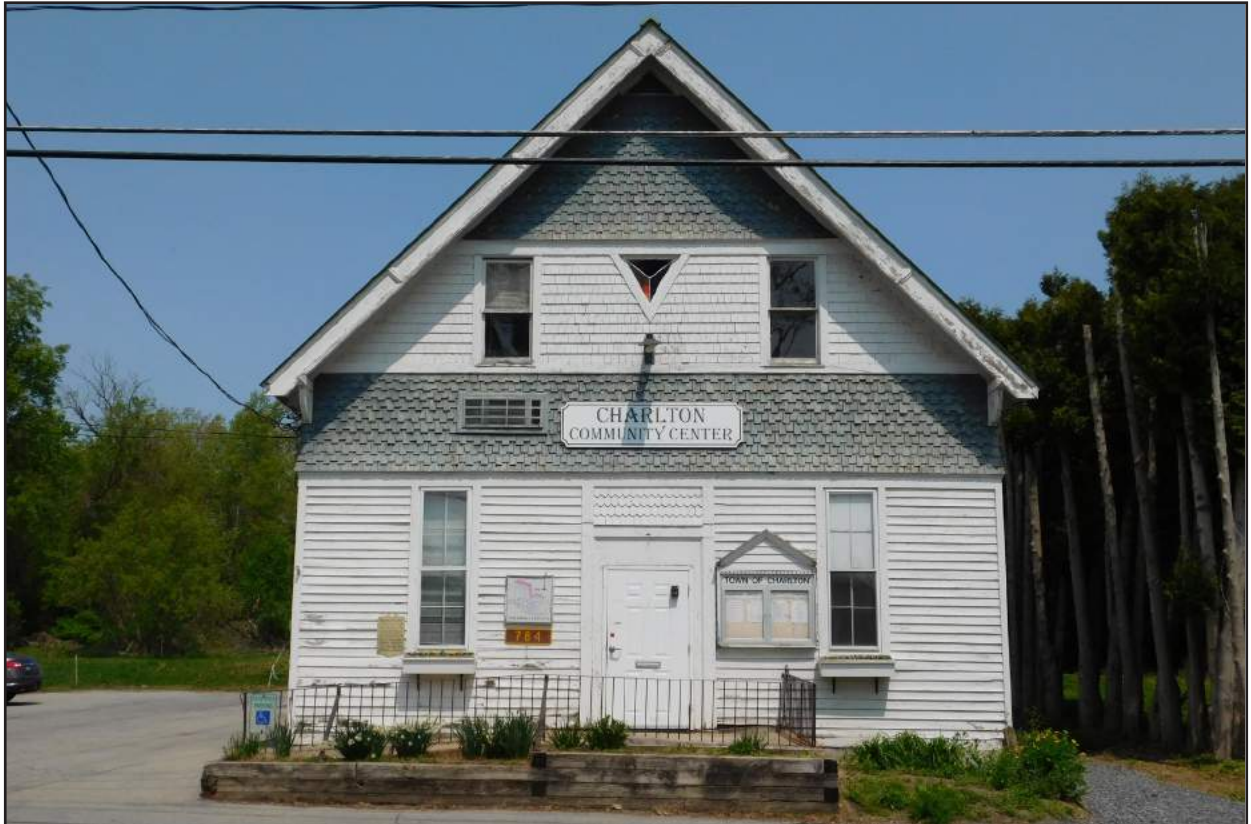
Figure 35 South elevation.
